433 Spruce Brook Road

1985 Townwide Historic and Architectural Survey of Berlin, Connecticut. Survey # 159

HISTORIC RESOURCES INVENTORY BUILDING AND STRUCTURES

1. BUILDING NAME (Common)		(Historic)	
David Sage Jr. House			
2. TOWN/CITY	VILLAGE	COUNTY	
Berlin		Hartford	
3. STREET AND NUMBER (and/or location)		22-2/142/41	
433 Spruce Brook Road			
4. OWNER(S)			
Mihal, Debra J. " " Berlin 06037		<input type="checkbox"/> Public <input checked="" type="checkbox"/> Private	
5. USE (Present)		(Historic)	
Residence		Residence	
6. ACCESSIBILITY TO PUBLIC:	EXTERIOR VISIBLE FROM PUBLIC ROAD	INTERIOR ACCESSIBLE	IF YES, EXPLAIN
<input checked="" type="checkbox"/> Yes <input type="checkbox"/> No	<input type="checkbox"/> Yes <input checked="" type="checkbox"/> No		
7. STYLE OF BUILDING		DATE OF CONSTRUCTION	
Vernacular		c. 1752

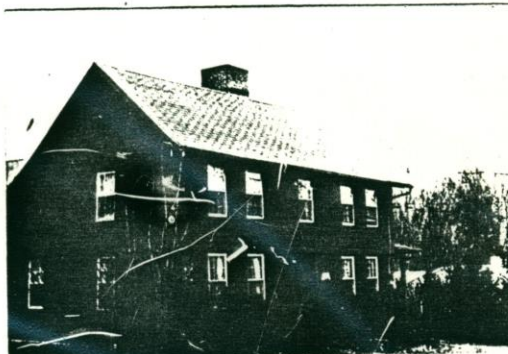
DESCRIPTION (Continued)	17. OTHER NOTABLE FEATURES OF BUILDING OR SITE (interior and/or exterior)	
	<p>The David Sage Jr. House has a five-bay facade with a central entry. The entry door is Victorian, with twin round-headed panels. Windows are fitted with recent or restored 6-over-6 sash. Facade windows are paired and offset towards the corners of the house; second-floor windows are located immediately under the eaves. There are hewn overhangs at the second floor and across the gable ends. The right elevation has a one-story flat-roofed porch on square chamfered Italianate columns. The porch has no rail and is partially framed-in. Side elevations have small round-headed attic lights. To the rear is an old if not original lean to and a cross-gabled extension.</p>	
SIGNIFICANCE	18. ARCHITECT	BUILDER

SOURCES	Tercentenary List.	
PHOTO	PHOTOGRAPHER HRC	DATE 11/84
	VIEW NE	NEGATIVE ON FILE H27
COMPILED BY	NAME Historic Resource Consultants	
	ORGANIZATION Colt Armory	
	ADDRESS 55 Van Dyke Avenue Hartford, Connecticut 06106
